Full Scale Dynamic Tests on One-Way Spike Barriers

January 1965

State of California
Highway Transportation Agency
Department of Public Works
Division of Highways
Materials and Research Department

FULL SCALE DYNAMIC TESTS
ON
ONE-WAY SPIKE BARRIERS

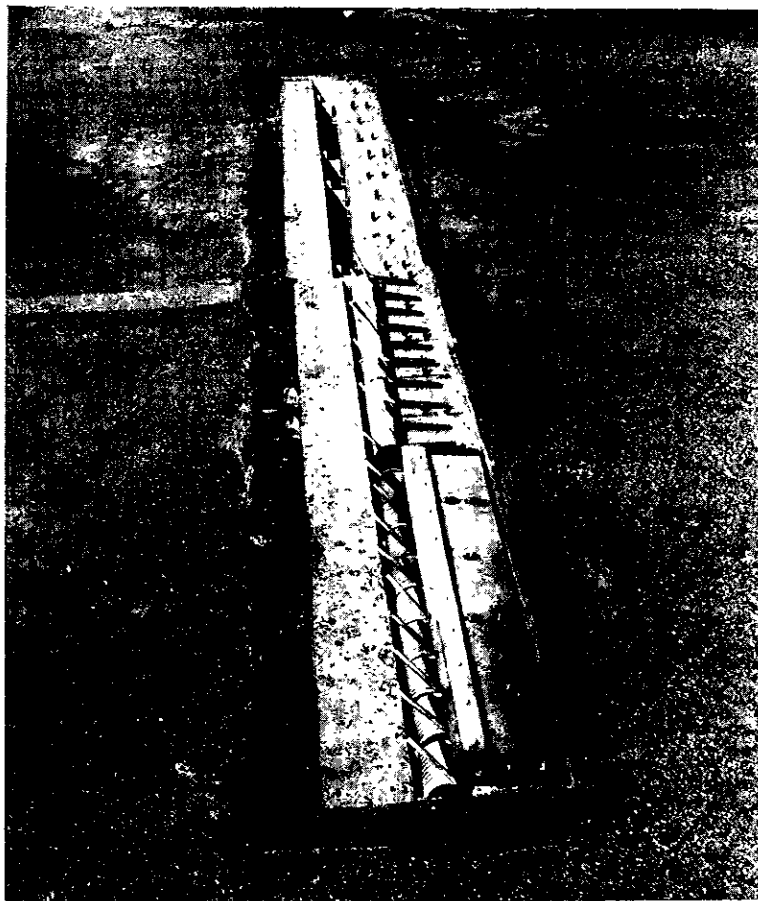
STANDARD SPIKE BARRIER INSTALLATION -- RUNS 1 THROUGH 11.

The standard spike barrier (Exhibit 1) will not effectively disable an automobile traveling against the spikes at speeds of from 15 to 60 mph for the following reasons: (1) spike penetration will puncture a tire but does not cause a blowout. The elapsed time from puncture to disablement or recognition by the driver that the tire is flat varies from 10 seconds to over 5 minutes. Due to the self-sealing properties of the tubeless tires used on modern vehicles, the puncture inflicted by this barrier frequently would not be severe enough to disable a vehicle in time to prevent its continued travel onto a freeway. (2) The spikes are not close enough together to prevent narrow tires (5:60 and smaller) such as are used on compacts and small foreign cars from passing between them (Exhibit 2).
